# Post Installation Performance of Cavity Wall & External Wall Insulation

# Executive Summary

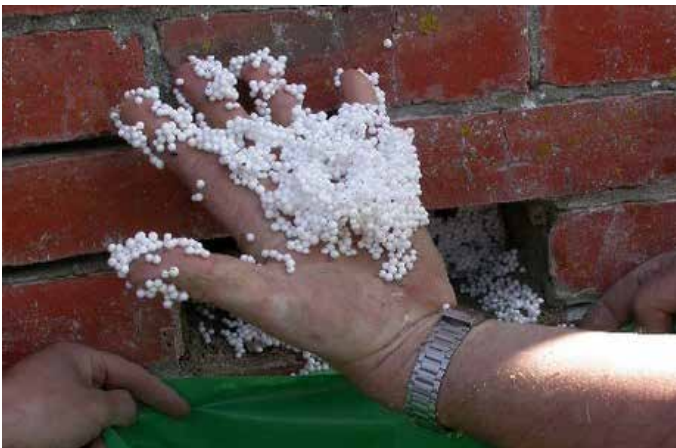
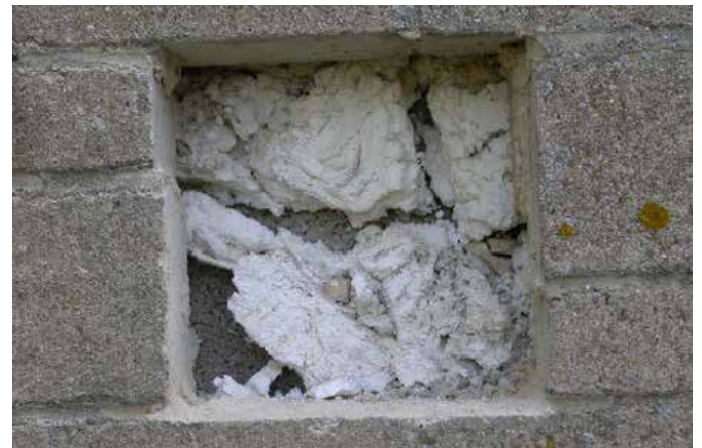
In this particular example the effect of rain water driving into the masonry of a building can be seen in Figures 3 and 4. The results are that the moisture penetrates the outer leaf brickwork leading to the wetting of the insulation materials, increased damp penetration and a reduced thermal performance of the material.

Figure 3: Example of saturated insulation

Figure 4: Example of saturated insulation

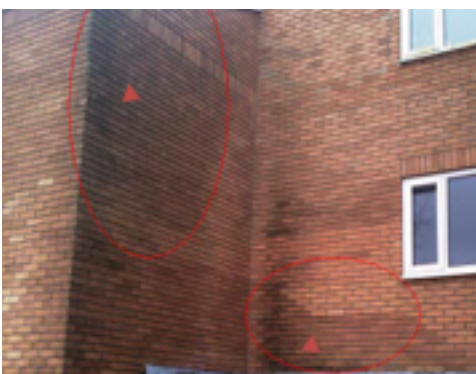
Many of the properties had experienced damage and deterioration as a result of the exposure to the weather. Mortar and bricks used in the construction are already saturated, with discolouration and mould growth evident. Examples are shown in Figures 5 & 6 below.

Figure 5: mould on saturated brickwork

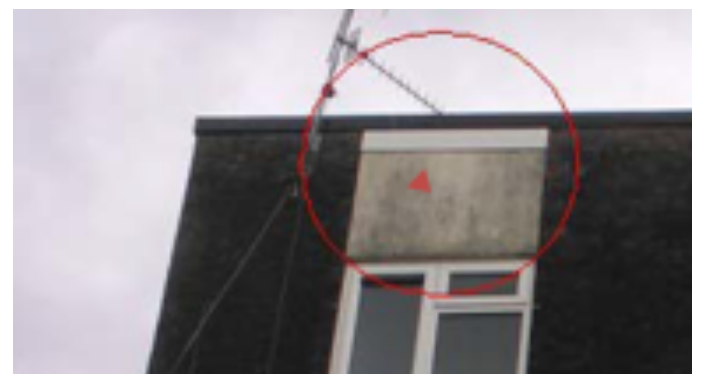
Figure 6: mould on saturated render panels

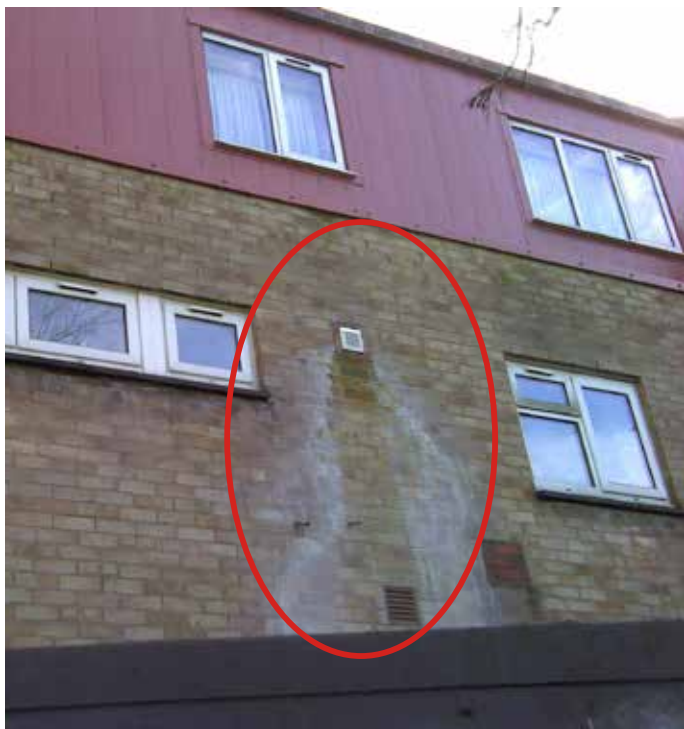
been repaired badly. This causes staining and increased risk of moisture penetration to the building, as shown in Figures 7 & 8.

**Figure 7:** Water dripping from extract fan cover and staining the walls

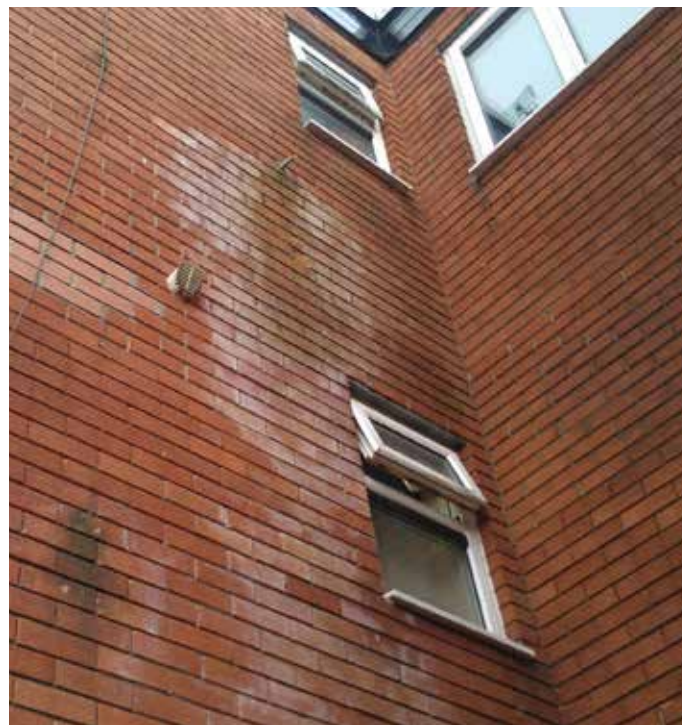
**Figure 8:** Leaking overflow pipe staining the brickwork

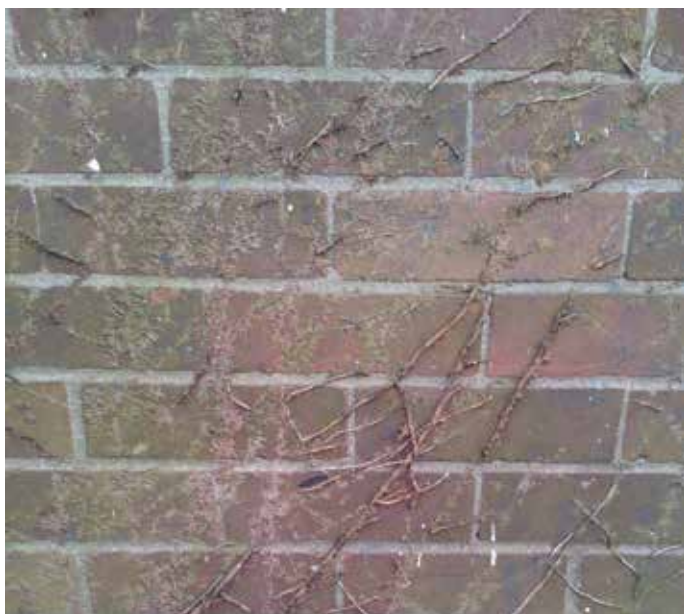
environment. If the plant growth is not addressed then this could help the wall become saturated, with an increased risk of the insulation in the cavity becoming damp. Examples of this damage are shown in Figures 9 & 10 below.

**Figure 9:** Plant growth attached to walls

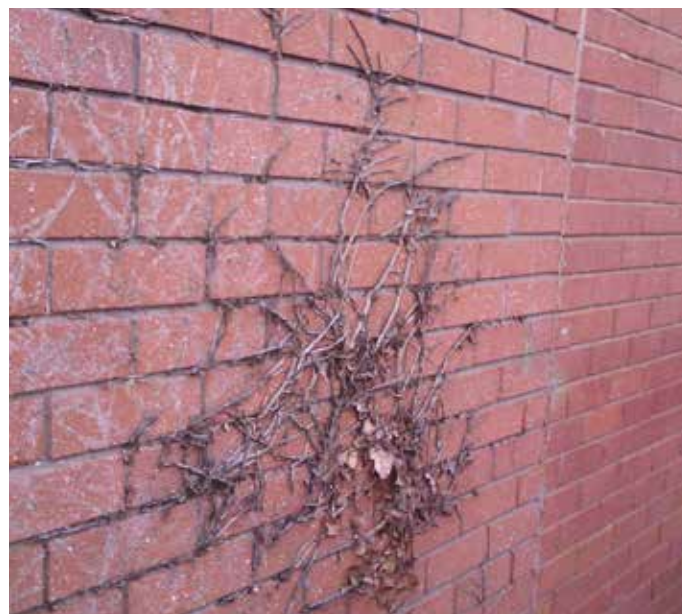
**Figure 10:** Plant growth and mould, indicating wet substrate

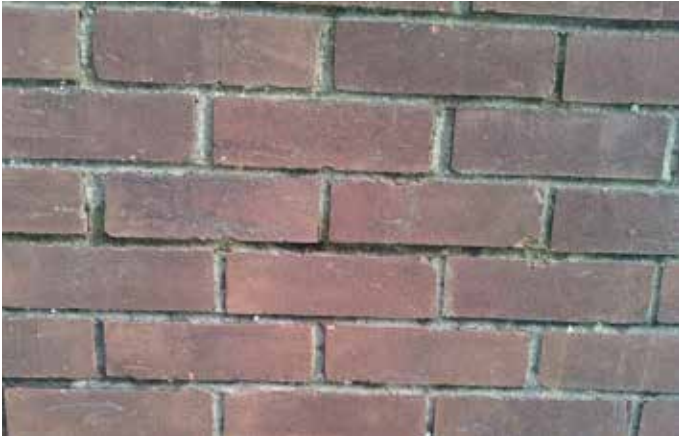
damage in the main would have been created by exposure to wind driven rain. Deteriorated mortar joints are entry points for moisture which can lead to any insulation in the cavity becoming wet.

Figure 11: Erosion of mortar by weather

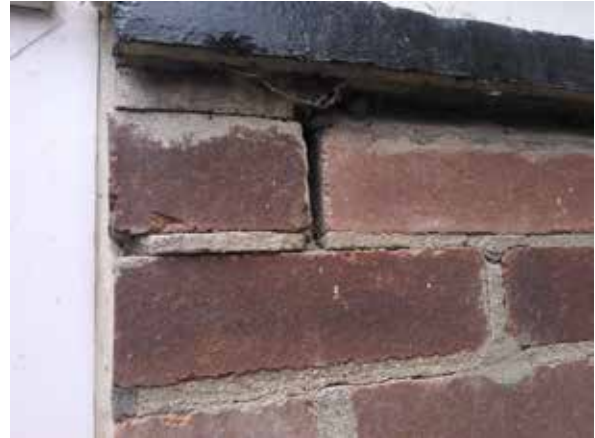
Figure 12: Cracked and missing

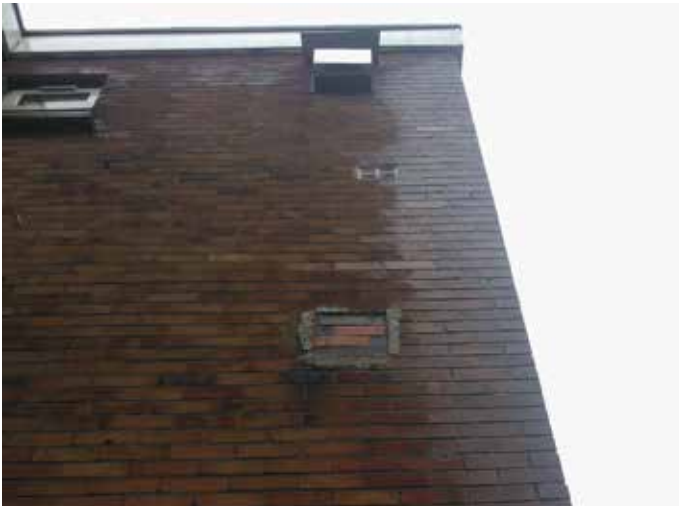
Figure 13: Wall staining from water blown off the roof

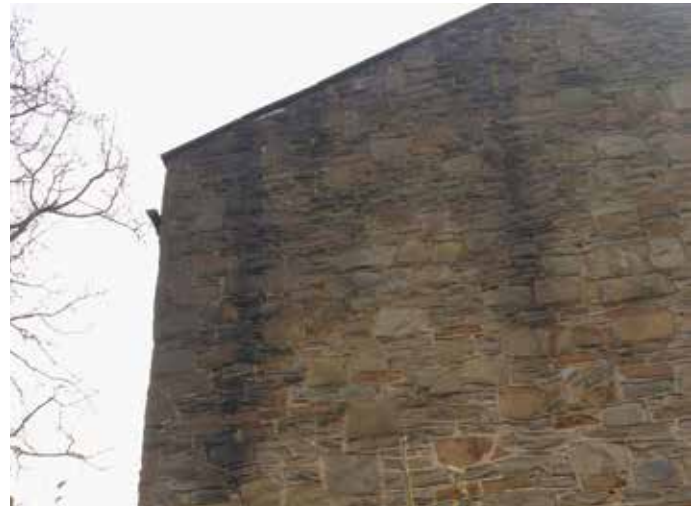
Figure 14: Staining from roof water run off

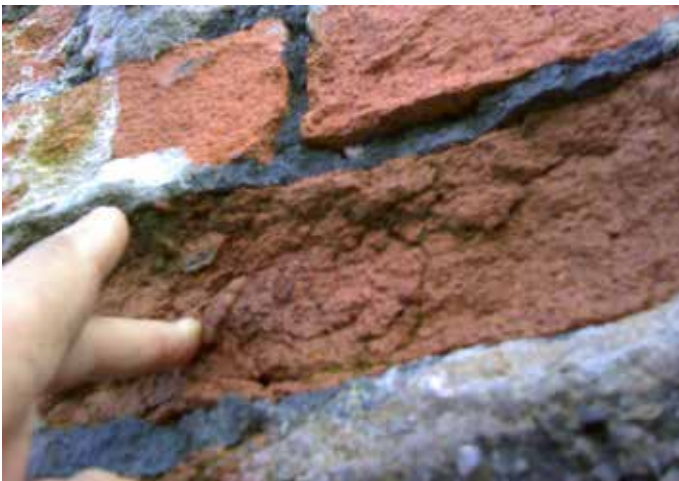
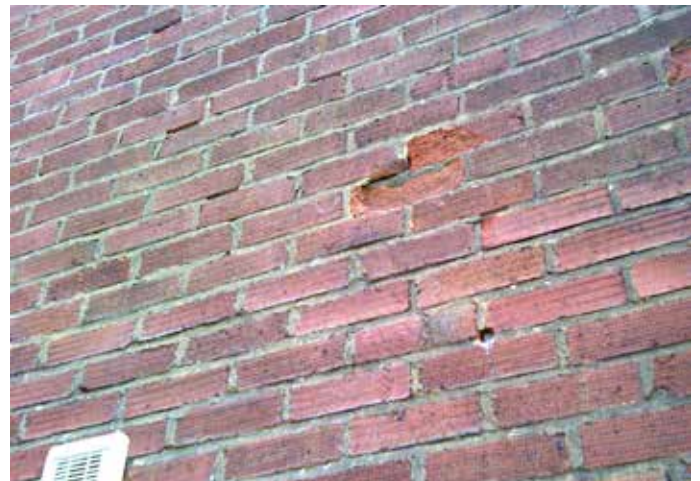
The results of the site surveys undertaken indicated by figures 15 and 16 show walls that have at some stage been saturated, and then excessive cold weather has resulted in "Freeze – Thaw – Frost" damage. With the faces of numerous bricks

being blown - severe frost damage and cracked rendering may permit higher than normal moisture content in the outer leaf. Insulation of the wall can be expected to increase the rate of deterioration.

Figure 15: Significant brick face loss

Figure 16: Missing brick faces

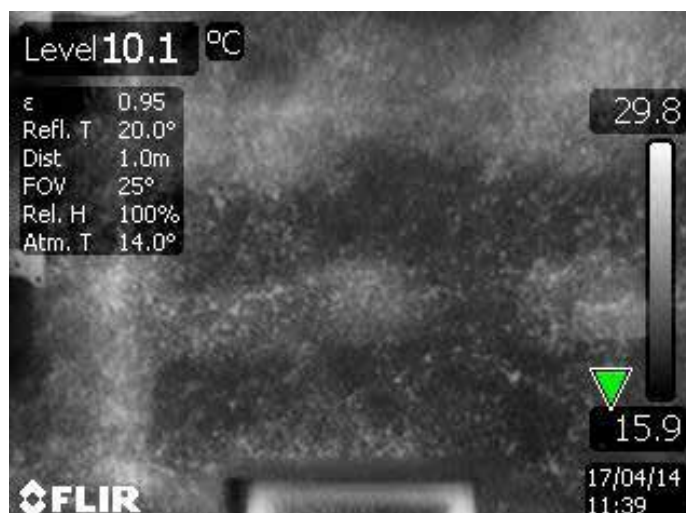
of continuity (voids) in the insulation, probably caused by either slump or incorrect installation procedures being used, with the darker areas indicating lack of thermal performance and cold bridging.

Dark patches indicating missing or slumped insulation materials.

Figure 21: Inconsistent insulation, shown on IR images

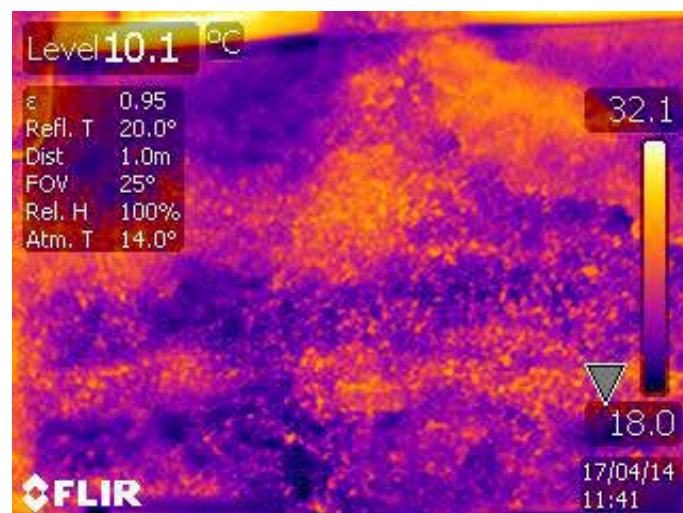
Figure 22: Inconsistent insulation in the same location

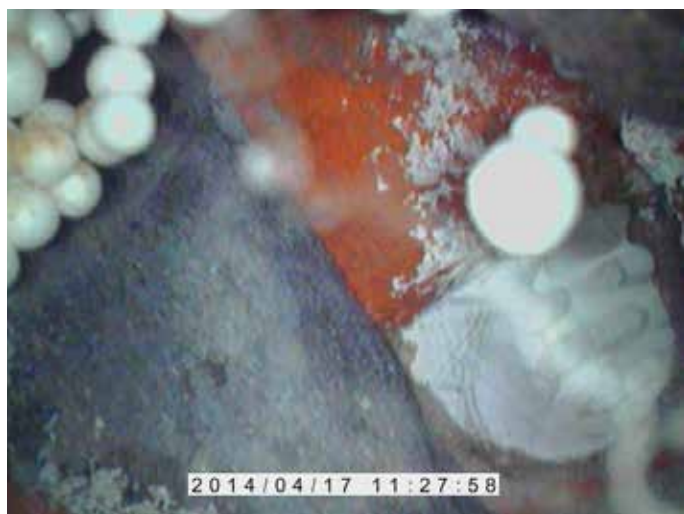
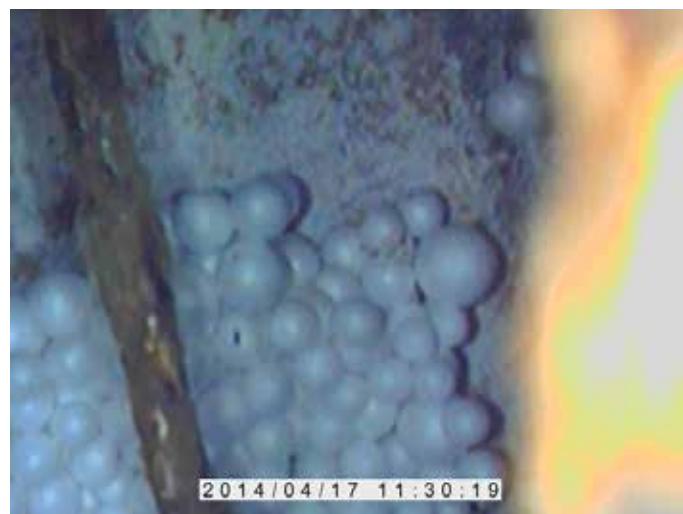
Close investigation of the voids being indicated by the IR imaging using a borescope camera confirms that in many places the insulation is in fact missing or slumped, examples of this can be seen in Figures 23, and 24 below.

Figures 23 & 24: Missing insulation below rear kitchen window and rear bedroom window

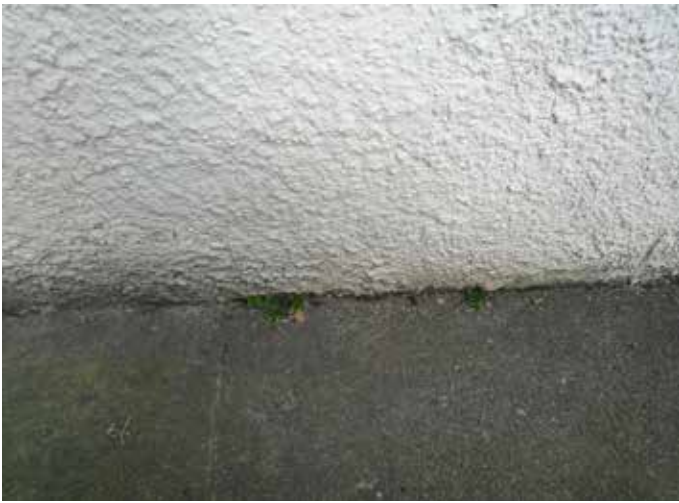
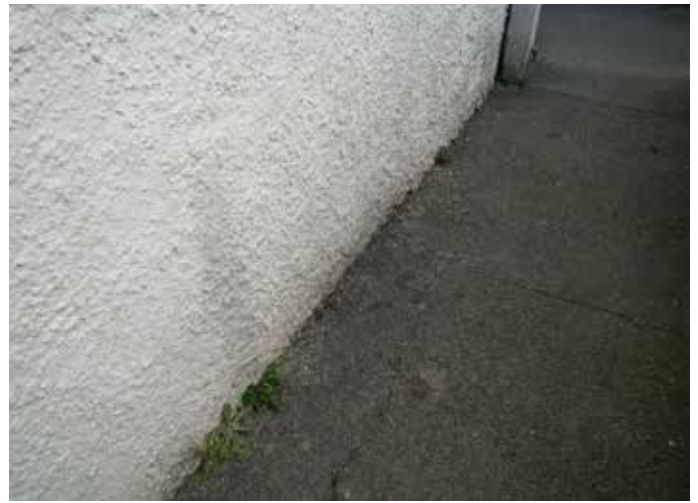
Figures 25 & 26: showing render to ground formation level at the rear of the property, and no weep holes

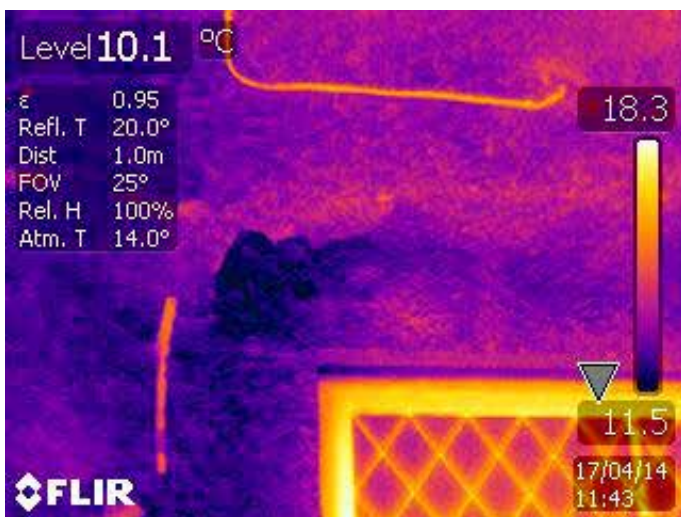
There are in addition other areas of cracked and spalled render shown in Figure 28. Cold bridging shown in Figure 27 may be leading to timber rot in the window frames to the property which will be allowing moisture ingress into the cavity area. We can conclude that the maintenance strategy for this property is insufficient and is likely to be leading to moisture entering the insulated cavity.

Figure 27: Cold Bridge introduced at area of spalled render.

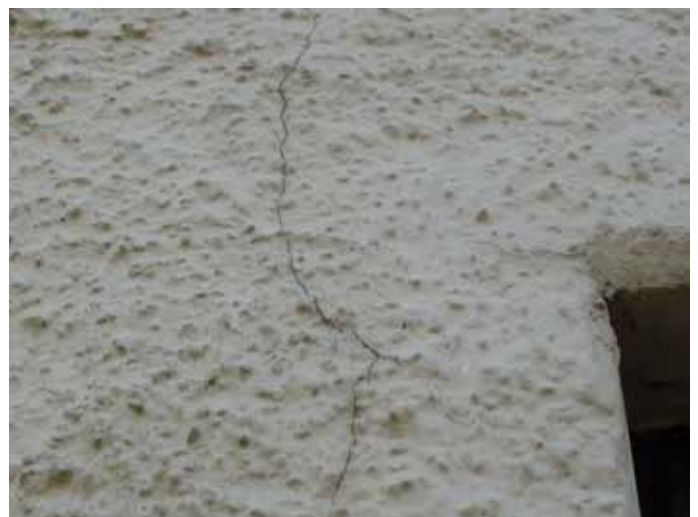
Figure 28: Cracked render at the property

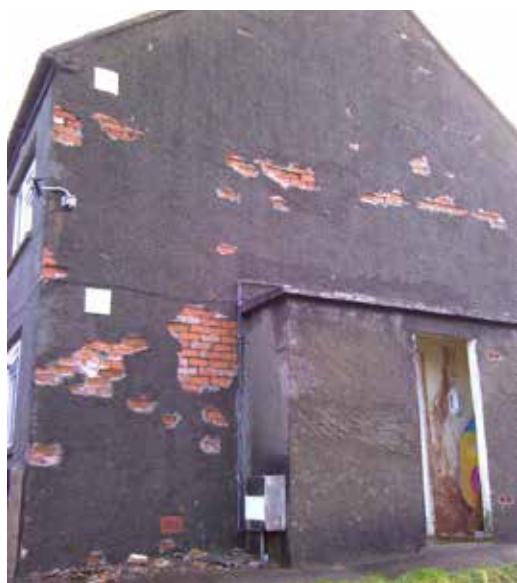
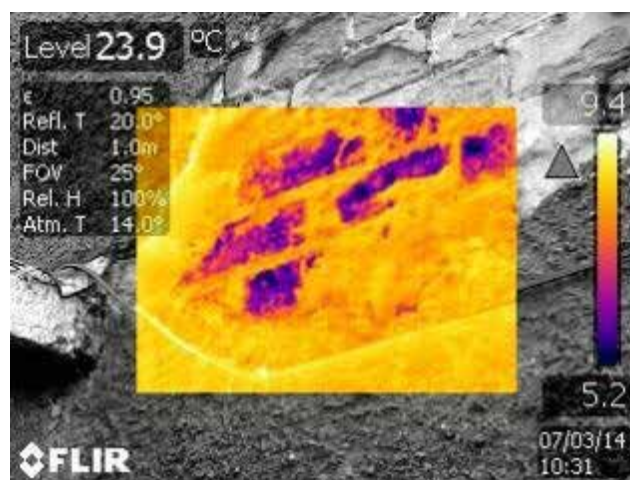
Figures 29 & 30: Gable end wall damage caused by saturation and blown render

Figures 29 & 30 show the level to which some of the render has deteriorated badly, due to the moisture content of the render and substrate.

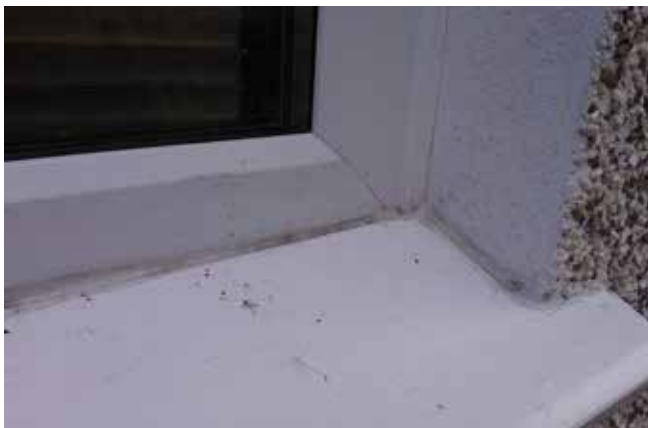
Examples of thermal bridging and poor installation of EWI are shown in Figures 31 & 32.

Figure 31: Uninsulated window reveal

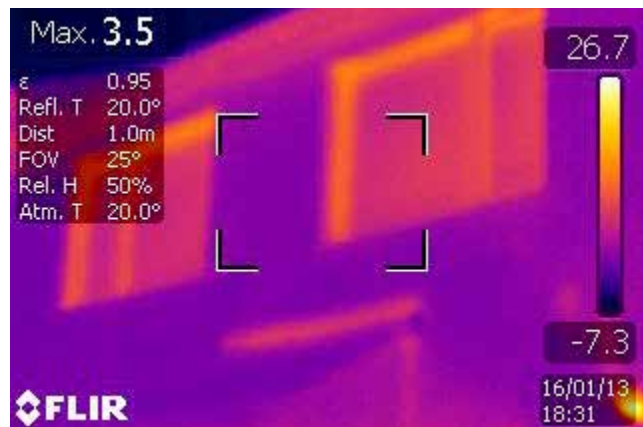
Figure 32: accelerated heat loss through an uninsulated window reveal

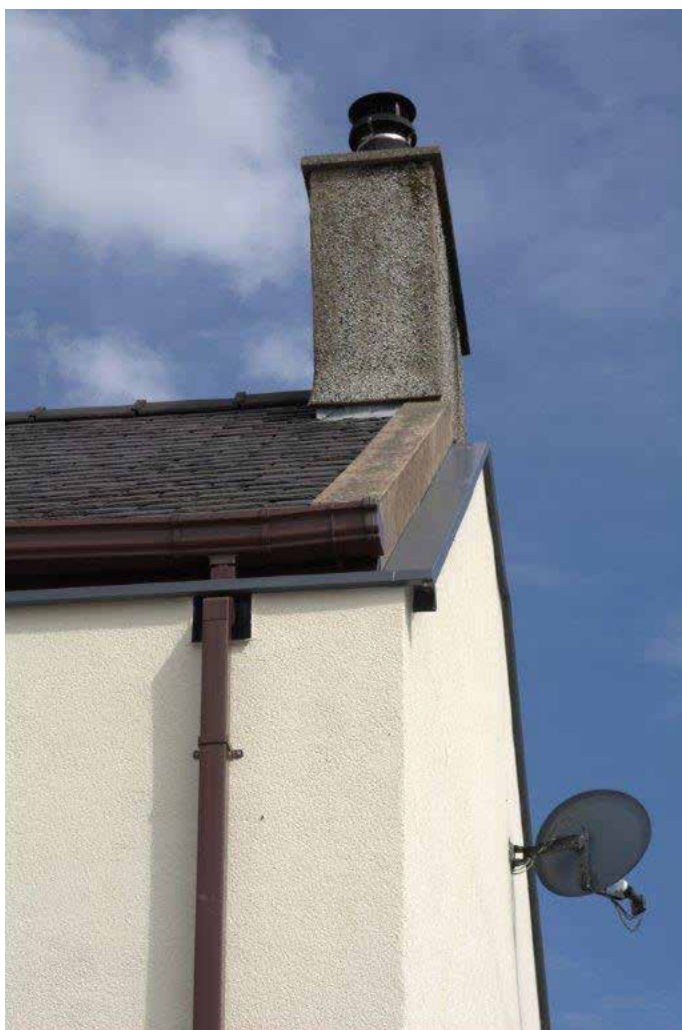
**Figure 33:** Roof of the building not extended to protect the insulation

flexible sealant to ensure water tightness. Good practice would dictate that roof line be extended by a minimum of 35-40mm passed the insulation, to provide protection to the top of the EWI system from inclement weather. An example of a typical roof that has not been extended is shown in Figure 33 below.

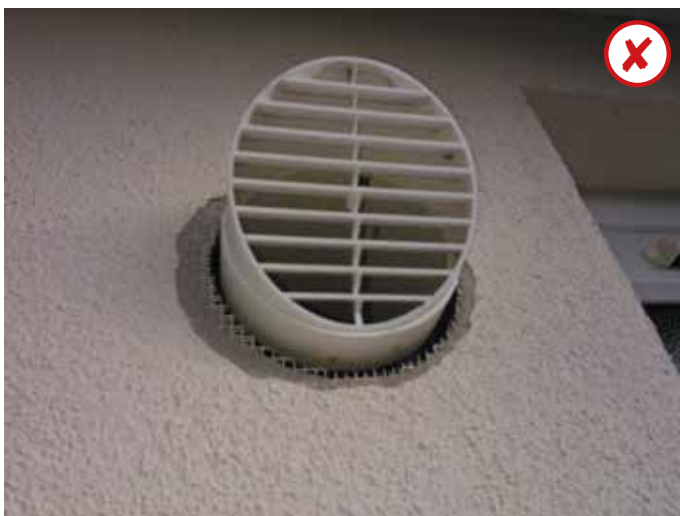
envelope is essential, whether by services or structure or construction. Where penetrations are unavoidable (ventilation exhausts and intakes, water supply, electricity and gas supplies), appropriate details for their proper execution should be developed. Where pipes or wires pass through the outside wall or the roof, installers should use a minimum seal around them to draught-proof the opening; this will help to reduce the potential for thermal bypass and a reduced efficacy of the insulation system.

Figure 34: Unsealed extract fan in a bungalow

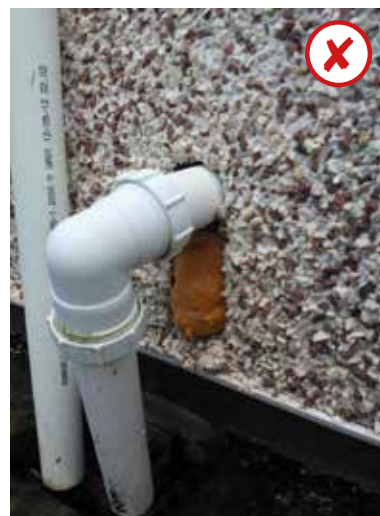
Figure 35: Unsealed pipe penetration

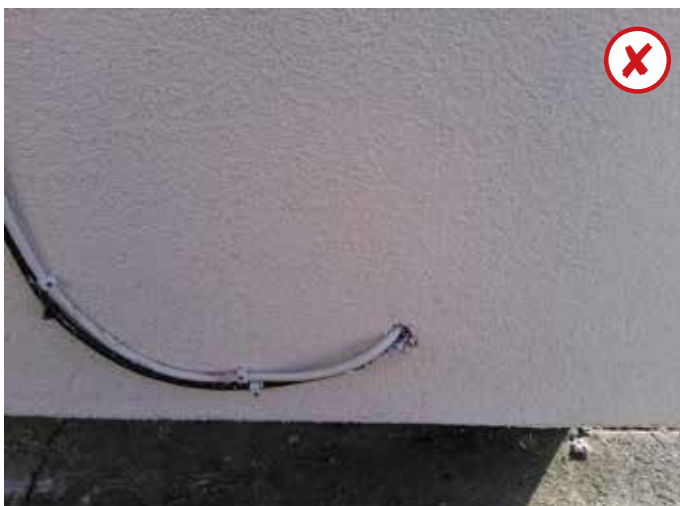
Figure 36: Unsealed wire penetration

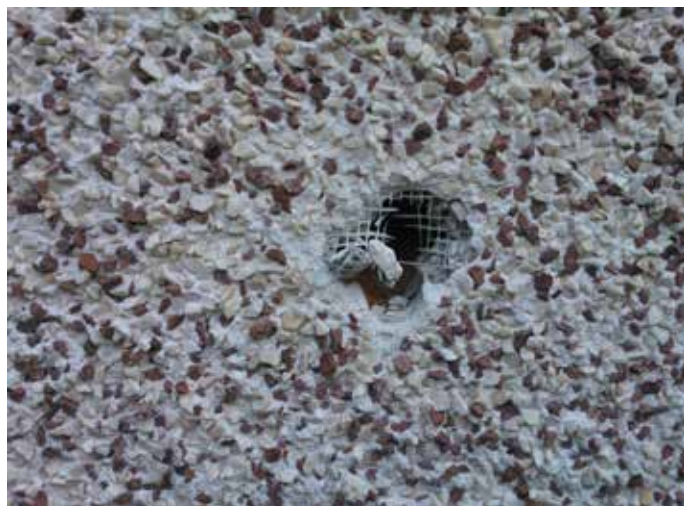
When undertaking external wall insulation cladding it is important that the quality of the finish is maintained and that there are no weaknesses in the finish which could allow the substrate of the wall or the insulation material to be exposed to the external weather conditions.

Figure 40: hole in a wall (from scaffolding used during construction)

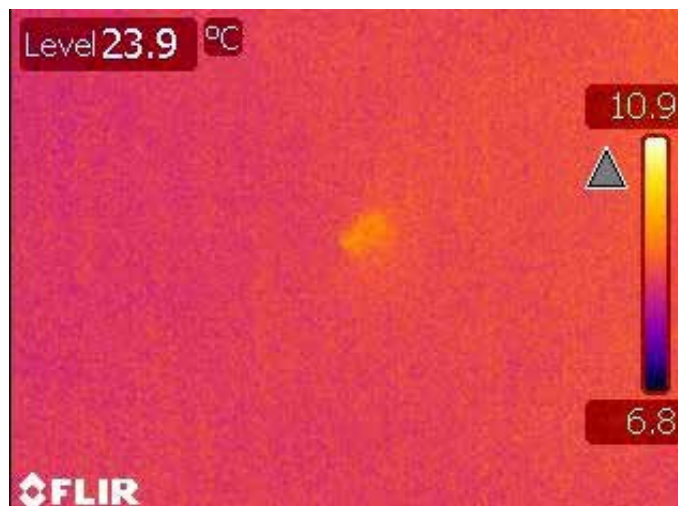
Figure 41: heat loss from the hole in a wall

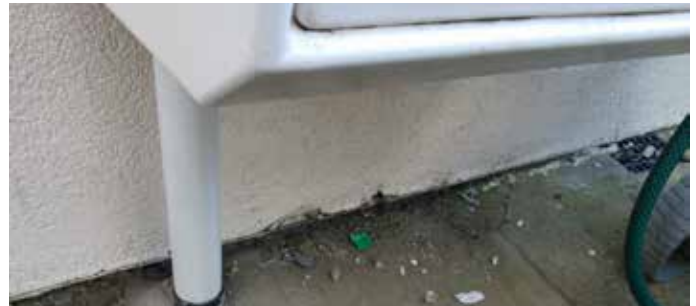
It is important when undertaking external wall insulation work of this nature that attention to detail is paramount. Poor or inconsistent finishing of details can and will lead to a reduced level of integrity, causing either early failure or poor performance. Figure 42 below shows an EWI starter track already deteriorating, although only undertaken seven months before the site survey. This increases the risk of moisture penetration to the main wall, and reduced life span.

Figure 42: Penetrating damp potential in external wall finish

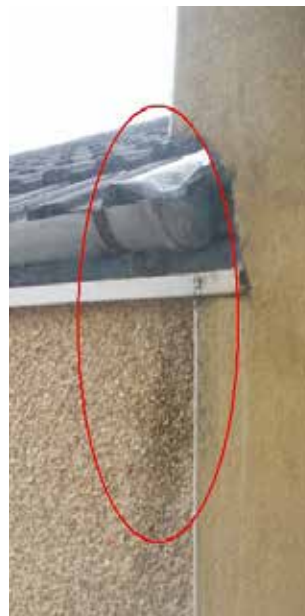
This type of poor detailing and workmanship can lead to reduced longevity of the systems, unsightly staining, external mould growth and to an increased risk of water penetration behind the insulation. This water penetration can lead to the wall becoming damp, due to the isolation from the effects of the sun this wall can then not dry out. The resulting effect is that the moisture tracks to the inner surface of the wall creating cold spots and the conditions were premature decay of the internal finishes, and mould can occur.

Figure 43: poor detailing

These types of poor detailing are completely avoidable with better site supervision and quality control checks on site.

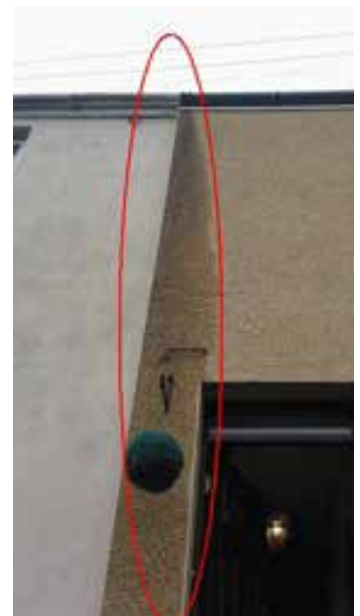
Figure 44: gutters connected of different material

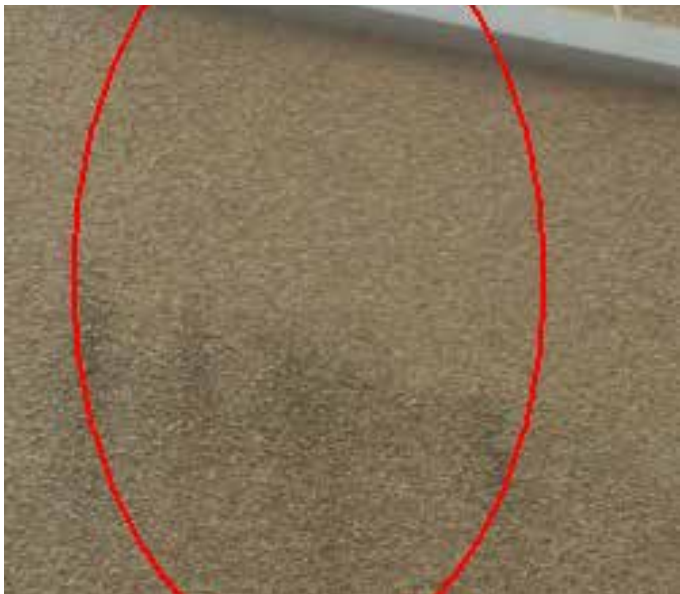
Figure 45: Staining by lack of capillary drip

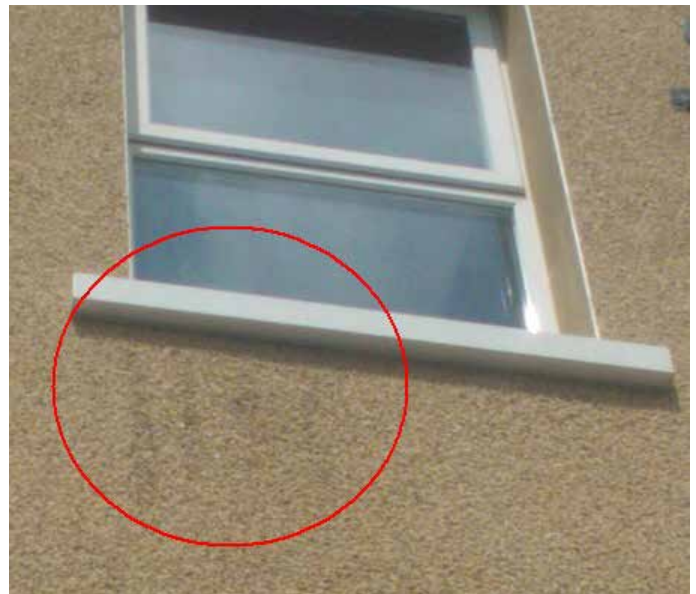
Figure 46: Incorrect finish of sill

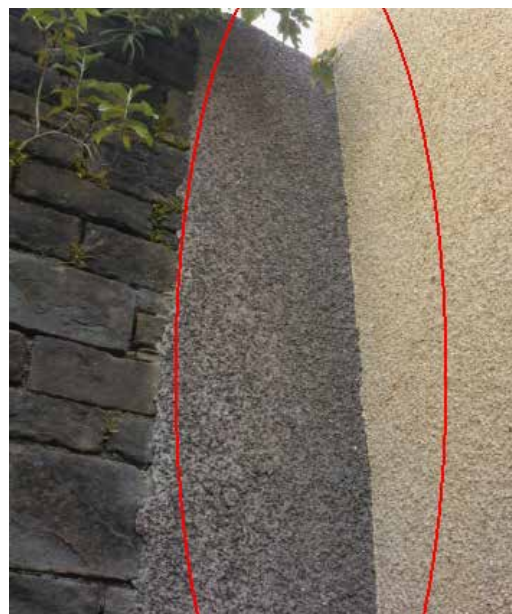
Common or standard practice results in the insulation being placed around the obstruction which increases the effect of the cold bridge, as discussed in FB61,<sup>12</sup> which demonstrates good practice and detailing when undertaking solid wall insulation.

Figure 47: Cold bridge exacerbated by placement of insulation around an obstruction

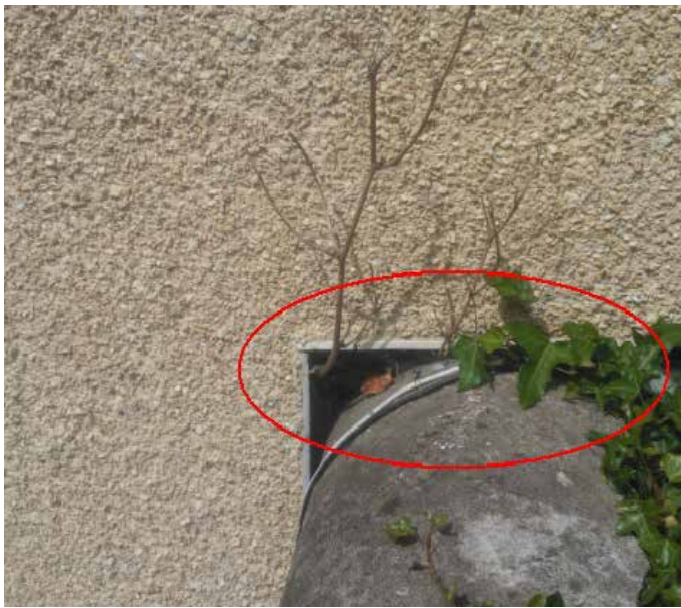
plant into the void left around the insulation. This plant is no doubt also sending roots behind the insulation which over time could lead to a destabilisation of the insulation boards and allow water ingress. Figure 49 shows plant growth on the existing wall that should be removed and cut back before the installation was undertaken, the site visit for this survey was undertaken less than one month after completion.

Figure 48: Plant growth allowed by poor detailing

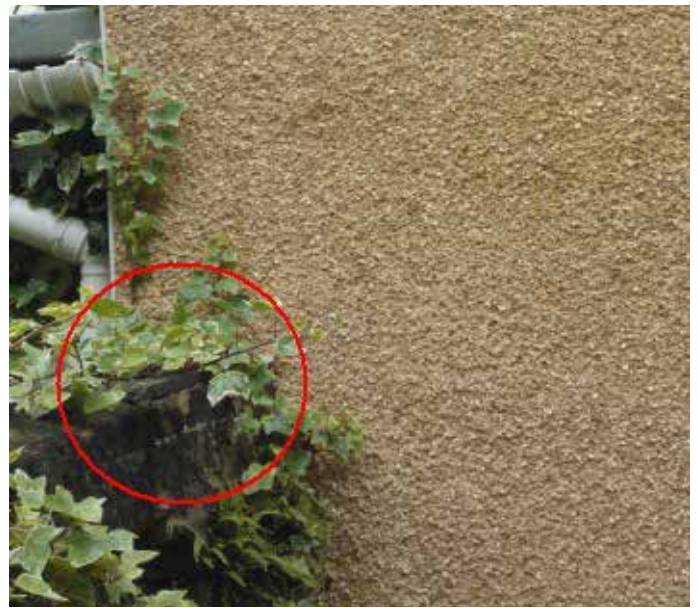
Figure 49: Close proximity of plant requiring pruning

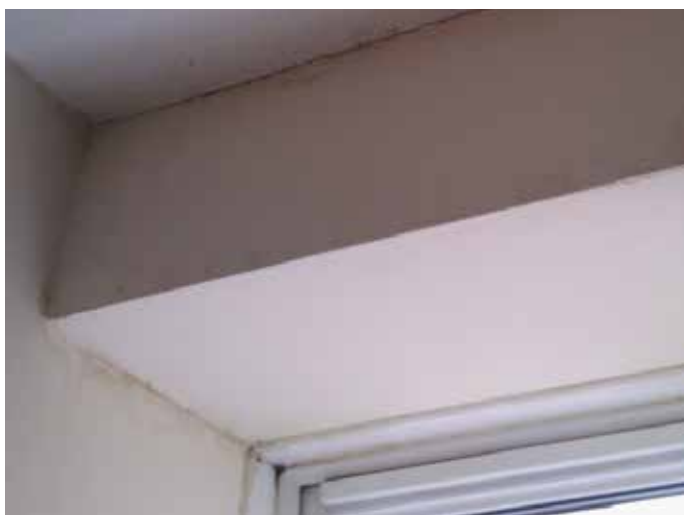
In the longer term, the issue with inadequate ventilation may prove to be more significant. Some housing providers reported issues with damp where none existed before, even though the EWI measures had only been fitted very recently.

Figure 50: Damp in the kitchen

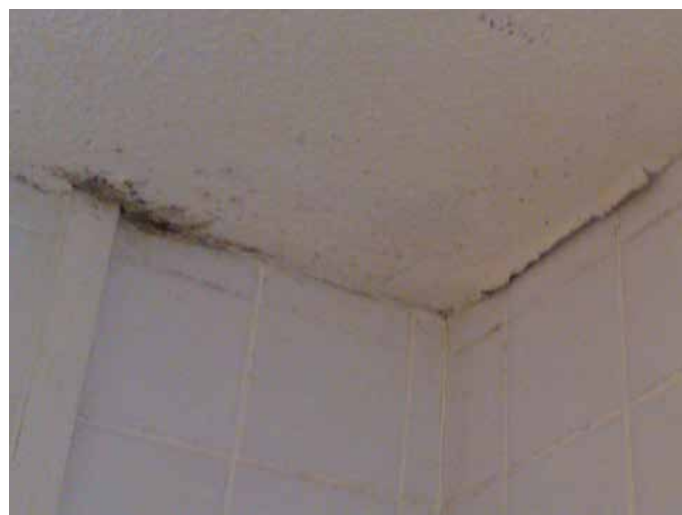
Figure 51: Damp in the bathroom

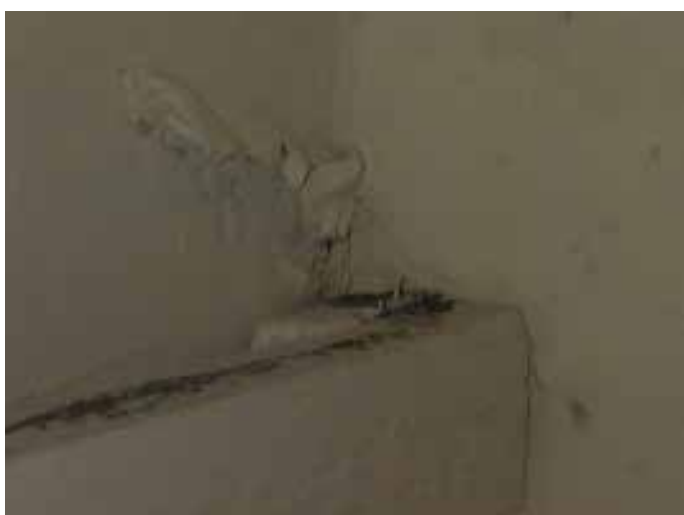
Figure 52: Damp in the wardrobe

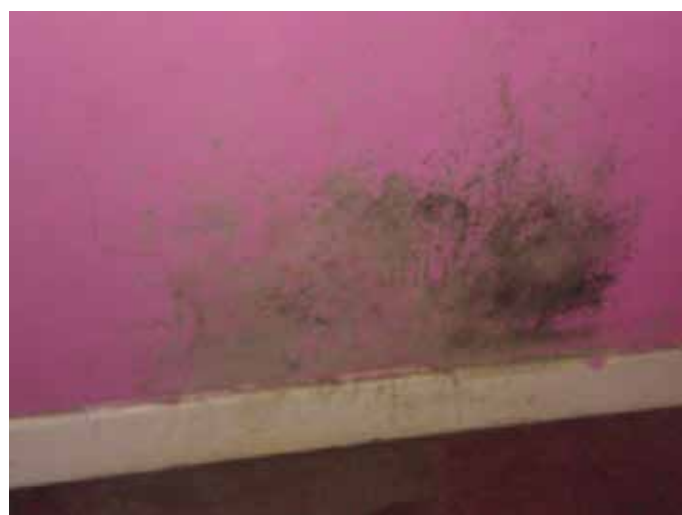
Figure 53: Damp behind a bed, removed for inspection
