# Post Installation Performance of Cavity Wall & External Wall Insulation

# Executive Summary

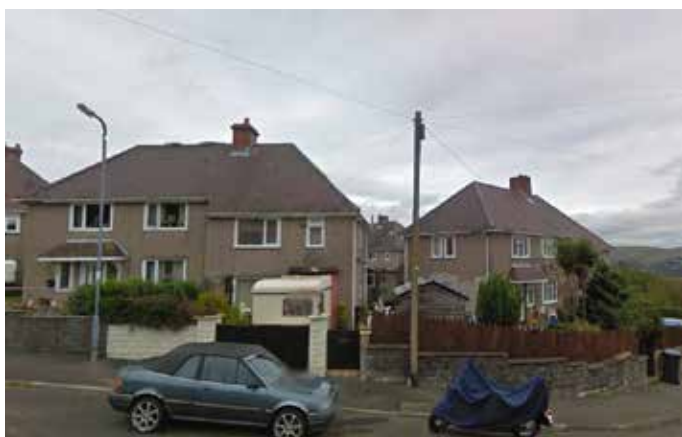
Figure 19: Typical property at Location 3

The physical inspections, confirmed the houses as being traditional, cavity wall, semi-detached houses. The dwelling typology is shown in Figures 19 & 20 below.

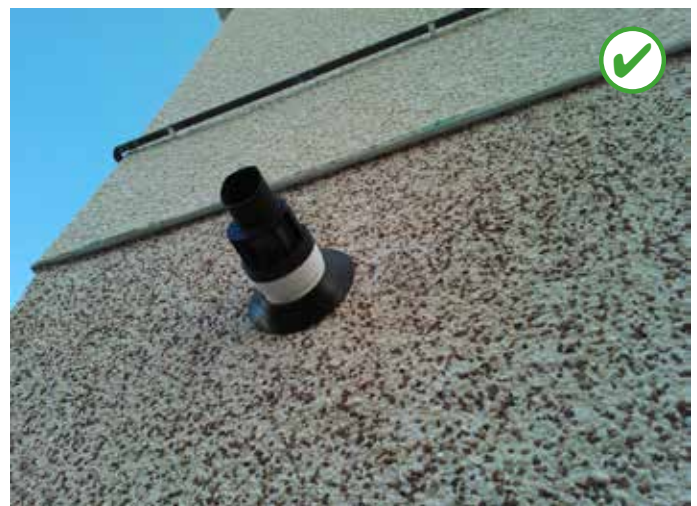
Figure 37: sealed penetration (good practice)

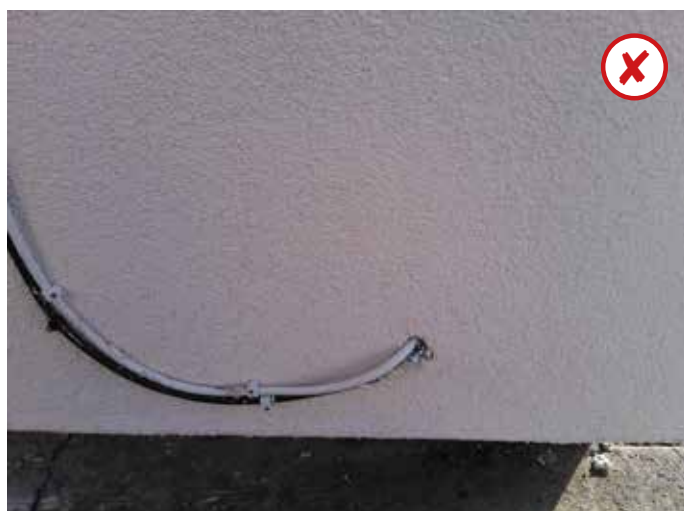
Figure 38 – cable clipped

The contractor is required to fit cable clips along the service route. These fixing elements should be spaced at maximum

250mm intervals for horizontal runs and 300mm for vertical runs. They must have sufficient strength to support the service cable. Unfixed cable may cause insulation damage in the future, by snagging or catching.

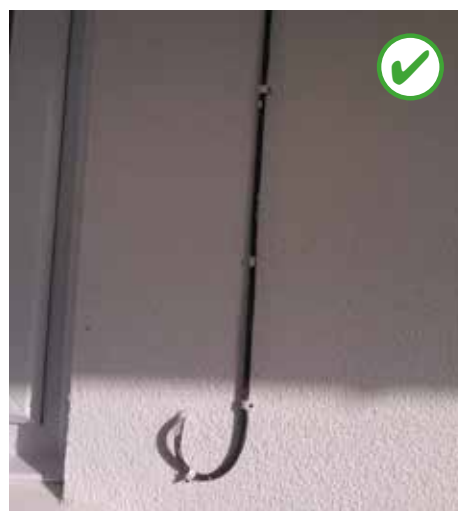
Figure 39 – cable clipped (good practice)

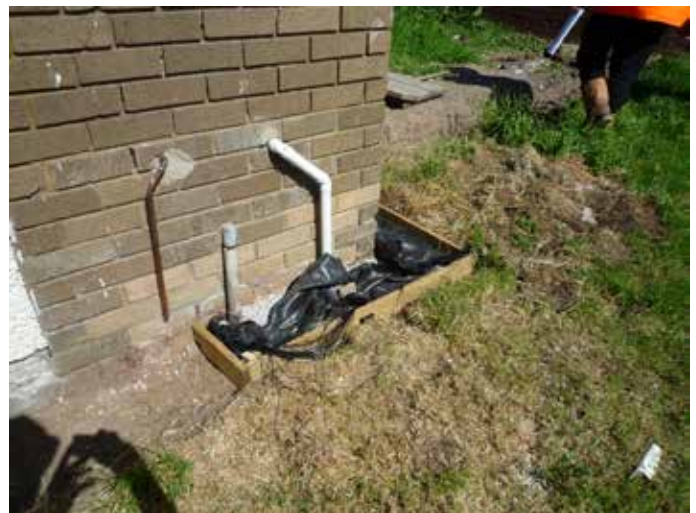
Figure 54: Ongoing works to provide soak away on raised ground areas.

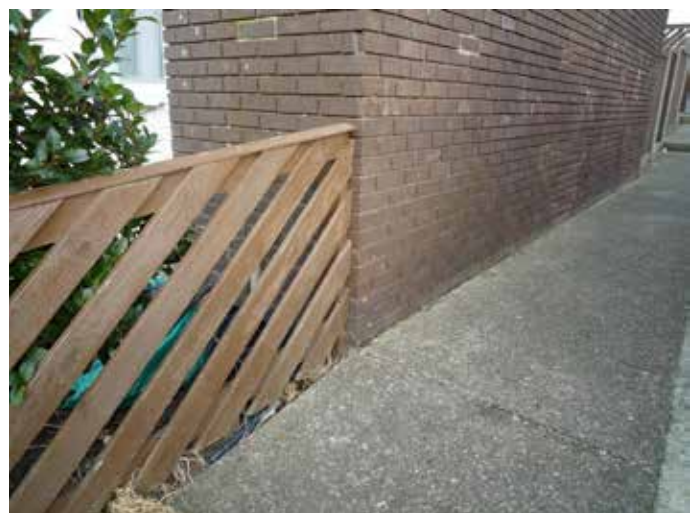
Fences and gates were tied into the dwellings at boundary edges see Figure 55. Fortunately, in this instance it was feasible to take down these features to allow the external insulation to be applied continuously to the walls at these points. This is preferable to installing the insulation around the existing feature, which would lead to a thermal bridge. There are some instances where it is not so practical to do this, such as at adjoining structures or porches (as is discussed below). In this case, fences and gates would be replaced after the EWI installation, ensuring that their mode of fixing would not damage the insulated render and would not introduce new detrimental thermal bridging points.

Figure 55: Typical fencing abutting main walls prior to EWI installation

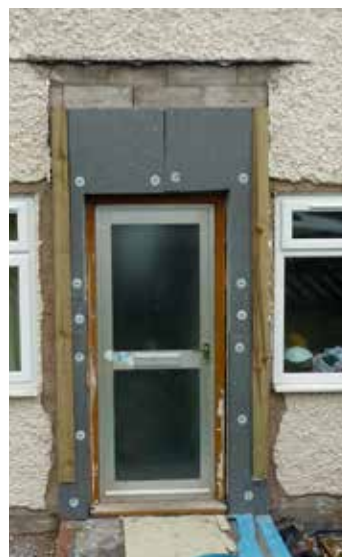
While it was possible to remove and replace some features around the dwellings to accommodate the externally applied wall insulation without introducing potential thermal bridging issues, the porches of the dwellings were more problematic because they were integrally tied into the structure of the buildings. It was therefore recommended that the porches be removed from the buildings and insulation applied behind where the porches had previously been tied into the structure. This would allow the continuation of the EWI across the front of the building where the porch had previously been attached. This could then be subsequently enhanced by the use of high performing insulation to minimise the cold bridge of the rebuilt porches, as shown in Figure 56 below.

Figure 56: Porch removed and cold bridge removed

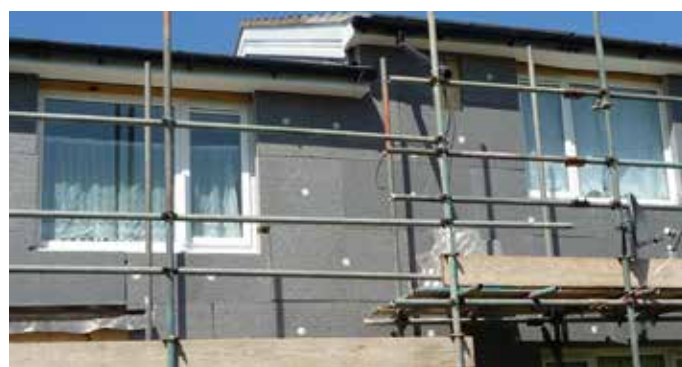
It is often the case in existing dwellings that the as-built original eaves and gable overhangs are insufficient to accommodate an additional layer of externally applied insulation. In such cases, it is common for installers to apply a finishing cap at the top of the insulation. However, there are reasons why this may not be considered ideal. The first is the overall visual appearance of the dwelling after such treatment, although this may go unnoticed by many people and is generally considered a low priority issue, and secondly this detail is reliant on flexible sealant to provide a watertight seal, which increases the risk of water penetration if not undertaken correctly or regularly maintained. Figure 57 shows good practice employed by Cartrefi Conwy, which is not only more aesthetically pleasing, but also reduces the cold bridging effects and potential risk of condensation and poor performance.

Figure 57: Extended eaves detail

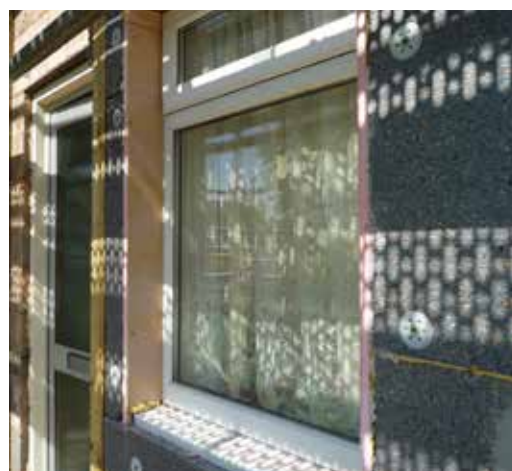
The choice of detailing of external wall insulation around windows can also introduce or exacerbate thermal bridging at the window reveals if the substrate wall surface remains exposed to the external environment behind the newly applied external insulation layer. This is quite common since often the thickness of the visible window frame is deemed to be insufficient to allow additional insulation to be returned into the reveal to cover the substrate wall and seal against the frame. Windows or doors may also limit the potential for this additional insulation to be applied if its thickness introduced an obstruction to the opening casement.

Figure 58: Insulated reveals and head

As the windows to the properties were modern and well performing, it was not a cost effective measure to remove and refix the windows to completely address the issues of cold bridging. The next best approach was taken the introduction of high performing insulation to the reveals and heads, as shown in Figure 58.
